Water Supply Lines

Galvanized Steel

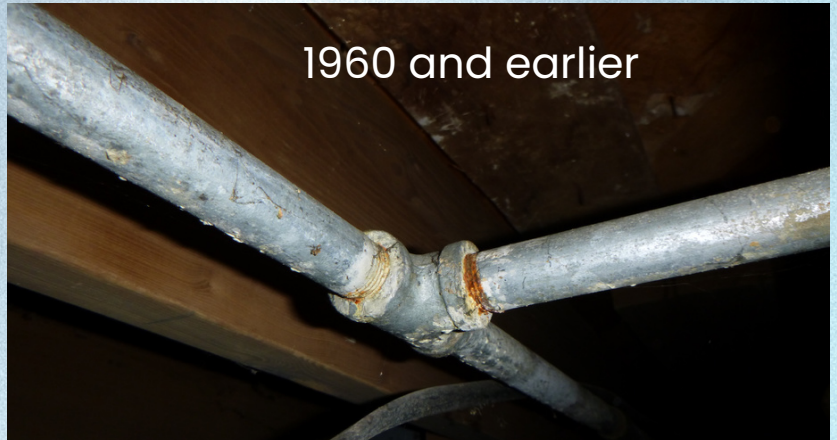
Galvanized Steel Water Supply Lines (dull gray/silver): Commonly installed in homes built before 1960. Based on its age alone, be aware that this material has exceeded its intended design life and will need to be replaced soon.

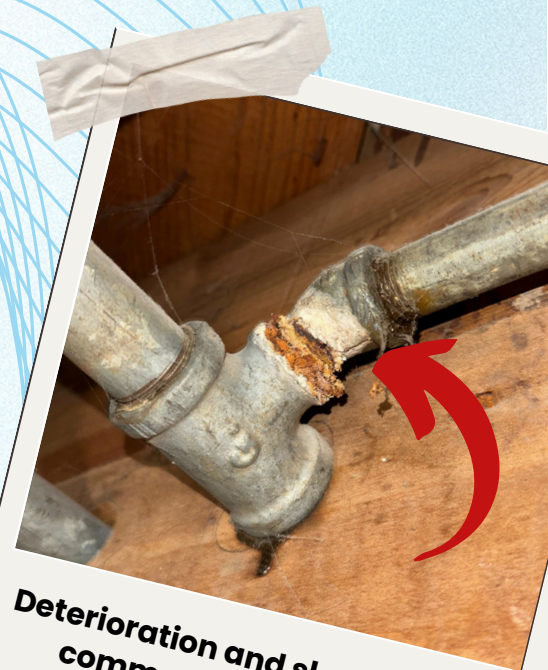
Deterioration and slow leaks are commonly seen at joints.
